Headliner Sags in the Rear

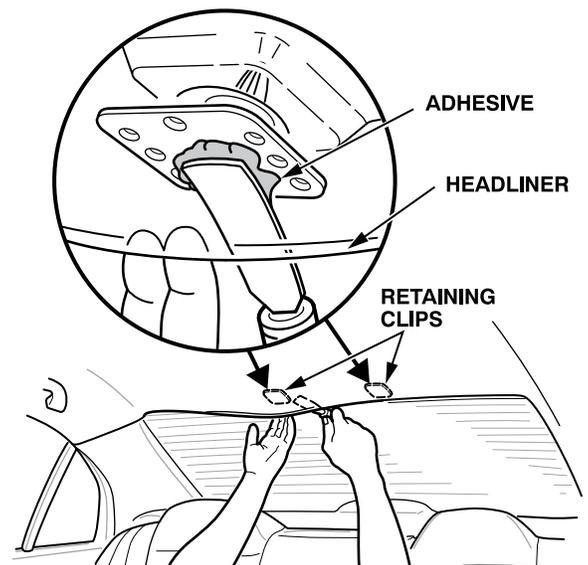
The retaining clips have detached from the headliner.

1. Put masking tape on the headliner and the rear window so you do not get adhesive on them.
2. Mix a small amount of adhesive in a container.
3. Carefully pull down the back of the headliner by each clip. Do not pull it down too far or you will crease the headliner.

4. Leave the clips attached to the roof. Apply a small amount of adhesive to each clip with a putty knife.
5. Slowly press the headliner against the clips. Support the headliner for at least 5 minutes with a rod that is padded at both ends.
6. Remove the masking tape you installed. Allow the adhesive to set for at least 4 hours before pulling on the headliner.
