Spotlight Lens Sticks

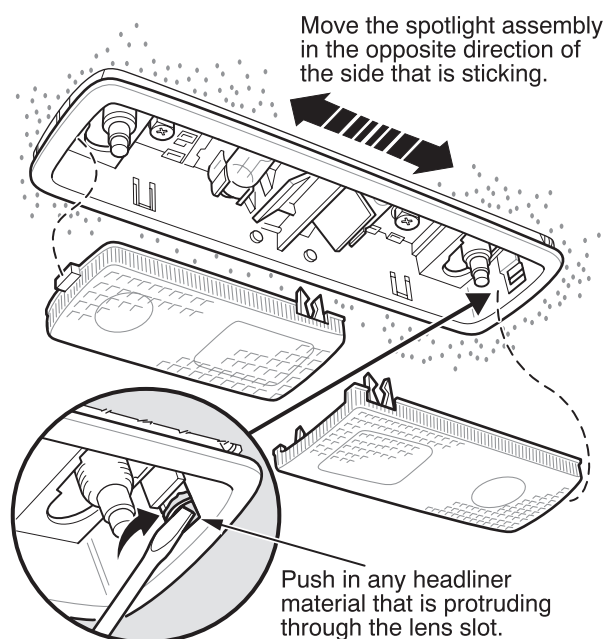
When the customer pushes on either the left or right lens to turn on a spotlight, it does not pop back out.

Headliner material is interfering with the lens, preventing it from moving freely.

1. Remove each lens by carefully prying on the inside edge with a small screwdriver.
2. Loosen the spotlight assembly mounting screws.
3. Move the spotlight assembly away from the side that was sticking. If the left lens was sticking, move the assembly to the right and vice versa. Tighten the mounting screws.

4. Use a small screwdriver to push back any headliner material that is interfering with the lens slot.
5. Reinstall the lenses and test the light.
 - If the lens no longer sticks, the repair is complete.
 - If the lens still sticks, remove the spotlight assembly and use a razor blade to trim the headliner material.
