Torque Converter Rebuilders Association

Honda TSB: Torque converter O-ring update

A/T DTC P0740, P0741

Tech Tip: Honda clutch failure

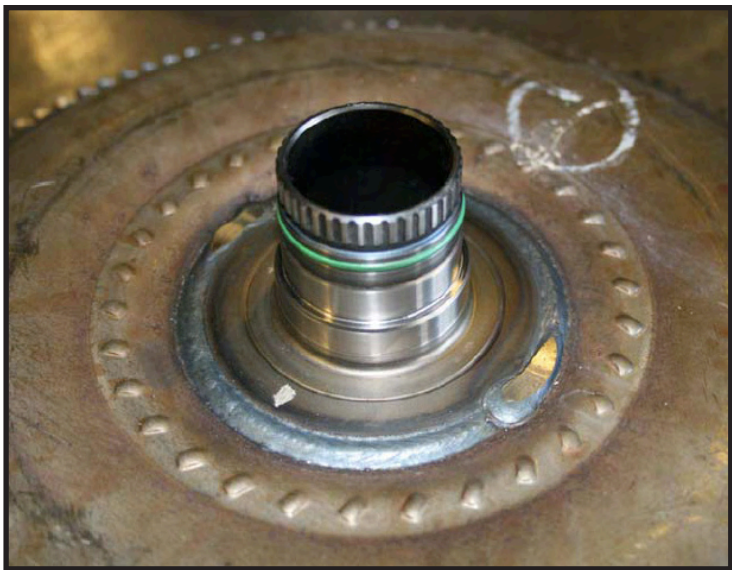
By now, many shops have seen problems with the late-model Honda converter clutch failures. There are several causes for these failures but one sure way to make sure it doesn't come back is to make sure that

According to our sources This new updated Green O-ring is .110" larger in diameter . The original Black O-ring is 1.440 and the green o-ring is 1.550. There are several different drive hubs with 36, 38, and 39 teeth. The OD of the hub for these drive hubs range from 1.520 to 1.575. So this part # will actually fit most Hondas and can be used in many applications.

your customer uses Honda fluid and the Updated Green O-ring from Honda with part number 91302PGK003. See Honda TSB above.

Try this combination the next time this failure occurs. You should find it to be a winning combination.
