**HONDA ServiceNews**

ASN 26422 (0311)

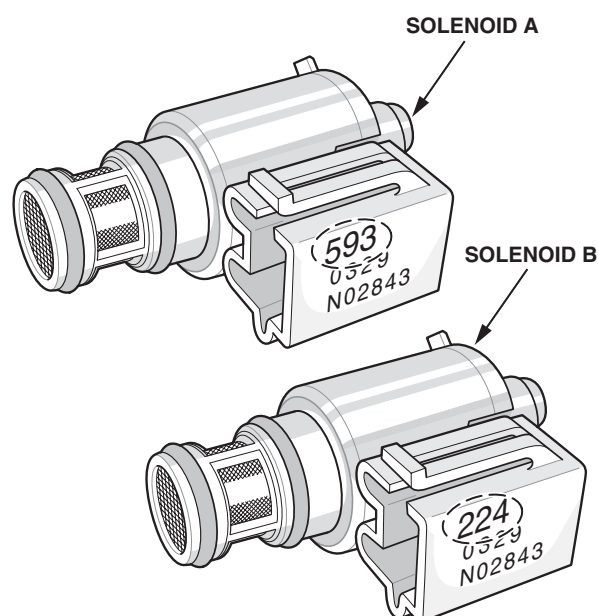
When installing these solenoids in the valve body, make sure you don't get them mixed up or install them in the wrong position. It's easy to do since these solenoids look almost identical. Fortunately, each solenoid has some of its part number engraved on its connector. Solenoid A has **593**; solenoid B has **224**.

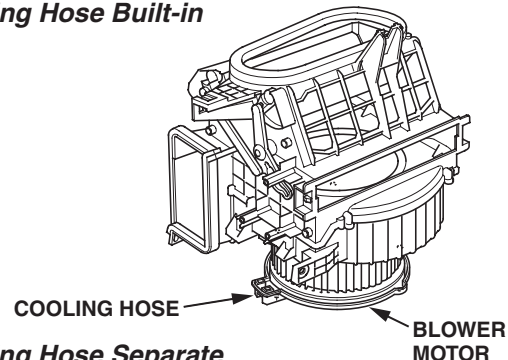
Cooling Hose Built-in

A blocked cooling hose for the heater blower motor can cause the motor to overheat, draw more current, blow a fuse, or even melt its plastic impeller. Before you order a replacement blower motor, make sure the cooling hose isn't blocked. On some models, you'll find the cooling hose molded into the blower motor housing; on other models, it's a separate piece. Check the S/M for the vehicle you're working on to determine the actual location of the cooling hose.
