Headliner Sags in the Rear

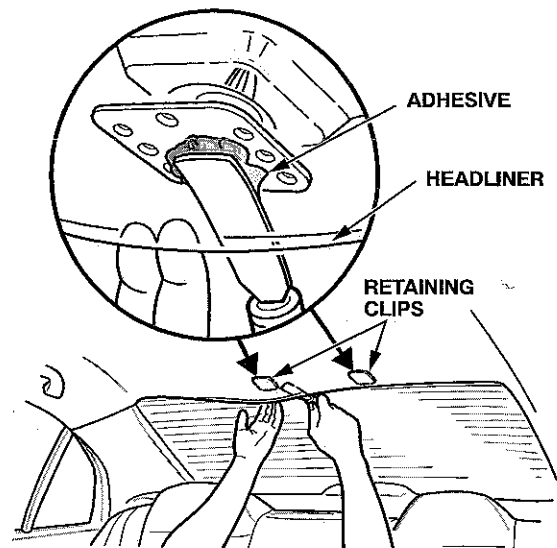
The rear of the headliner is sagging.

The retaining clips have detached from the headliner.

1. Mask off the headliner and the rear window so you do not get adhesive on them.
2. Mix a small amount of adhesive in a container.
3. Carefully pull down the back of the headliner by each clip. Do not pull it down too far or you will crease the headliner.

4. Leave the clips attached to the roof. Apply a small amount of adhesive to each clip with a putty knife.
5. Slowly press the headliner against the clips. Support the headliner for at least 5 minutes with a rod that is padded at both ends.
6. Remove the masking tape you installed. Allow the adhesive to set for at least 4 hours before pulling on the headliner.
