Manual Transmission Will Not Shift, the Clutch is Slipping, or the Vehicle Won't Move When in Gear

Year	Model	Trim	VIN Range
2020 – 2021	Civic (1.5L T Engine)	LX, EX, Sport, Si (with M/T)	ALL

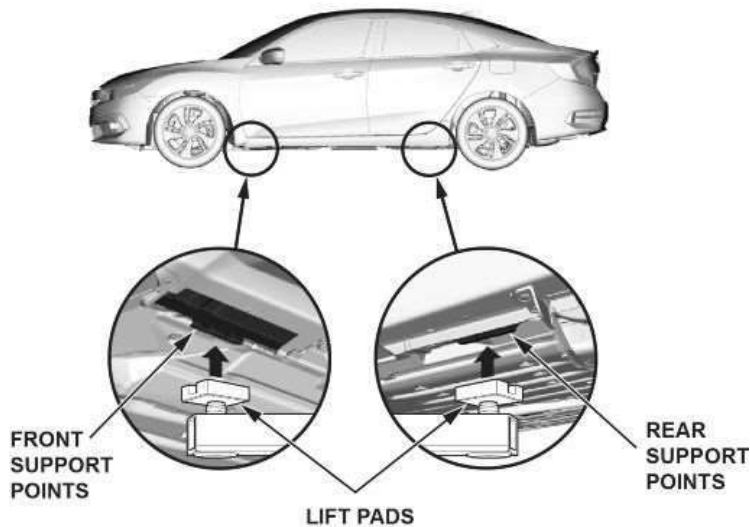
1. Support and raise the vehicle:
 - 1.1. Position the lift pads under the vehicle's front support points and rear support points.

- 1.2. Raise the lift a few inches, and rock the vehicle gently to be sure it is firmly supported.
- 1.3. Raise the lift to a comfortable working height and inspect the vehicle support points for solid contact with the lift pads
