Applies To: **1998-02 Accord** – ALL
1998-04 Civic – ALL
1999-03 Odyssey – ALL
1998-01 Prelude – ALL
2000-04 S2000 – ALL

Deformed Windshield Molding (Supersedes 00-064, dated August 12, 2003)

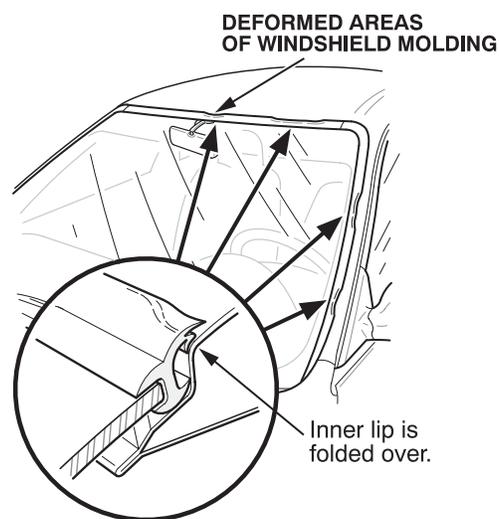
Pull up the outer edge of the windshield molding. Check if the inner lip is folded over anywhere.

- If the inner lip is folded over, go to REPAIR PROCEDURE.
- If the inner lip is not folded, disregard this bulletin, and look for other possible causes.
