# Torn Turbine Hub Weld Leaves Honda Pilot Stranded

by Joe Rivera

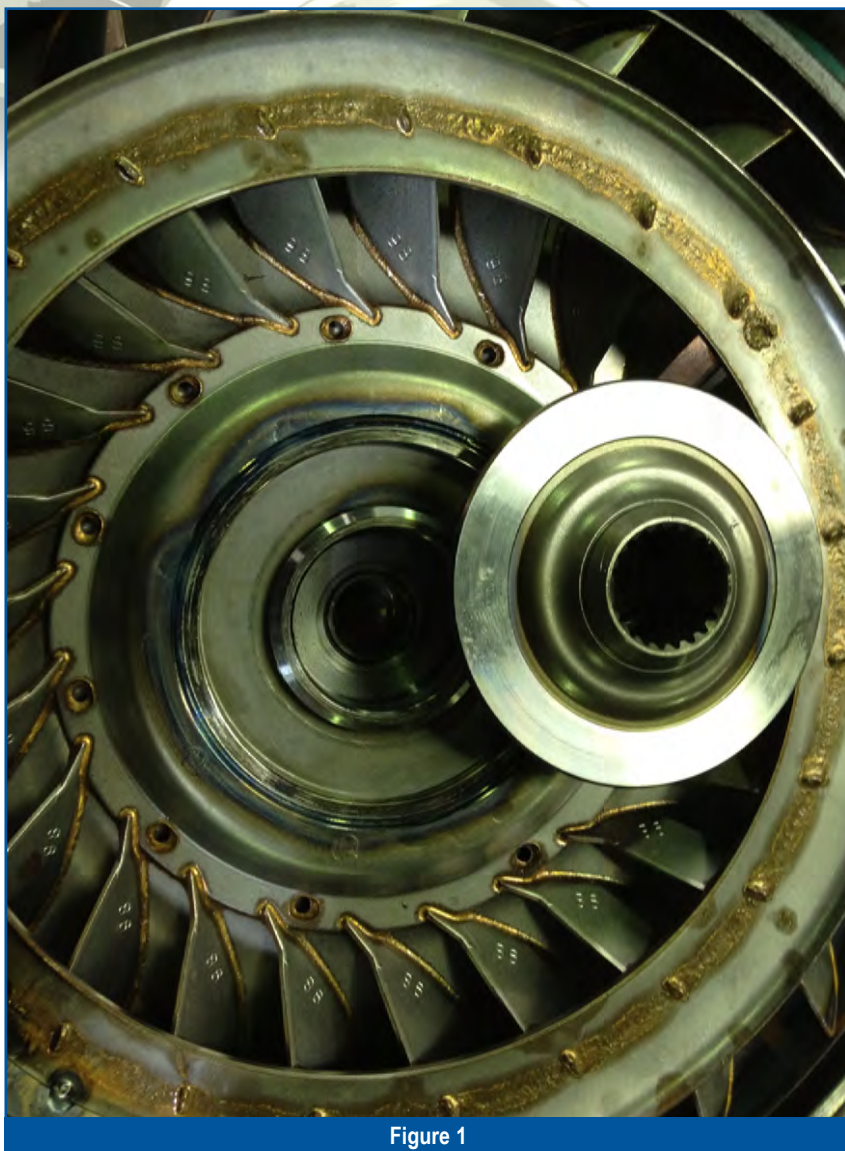
Figure 1

verter all along; and from the looks of the broken weld (figure 1), we may be seeing a lot more of these Hondas in the future.

What happened was the weld that holds the splined hub to the turbine broke free, so there wasn't any torque reaching the transmission input shaft. Everything was working fine, except the drive train wasn't rotating, so of

the problem was obvious: The weld didn't hold. And from the looks of this weld, we're probably going to be seeing a lot more of these Hondas in the future with the same problem.

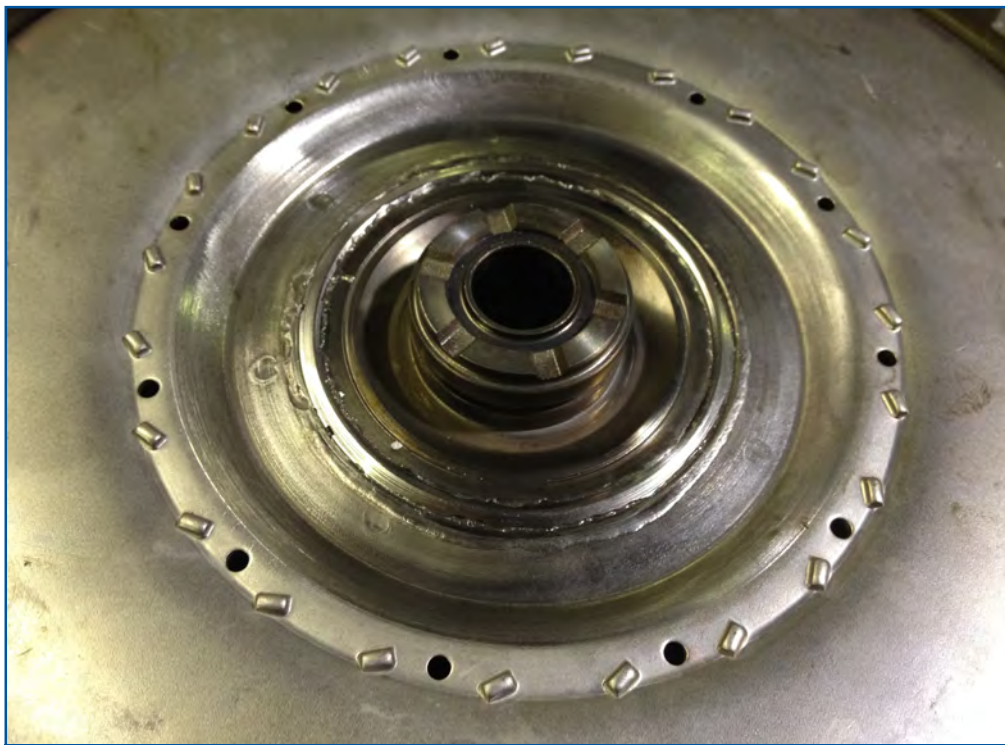
Figure 2

When fixing them, the converter rebuilder should machine the hub to make sure it sits down properly on the turbine, and provides enough clearance for the mating components

When fixing them, the converter rebuilder should machine the hub to make sure it sits down properly on the turbine, and provides enough clearance for the mating components (figure 2). And I'd recommend welding it on both sides to make sure it's secure.
