Applies To: **2001-02 Civic EX** – See VEHICLES AFFECTED

## Driver's Seat Rocks

(Supersedes 01-057, dated September 2001)

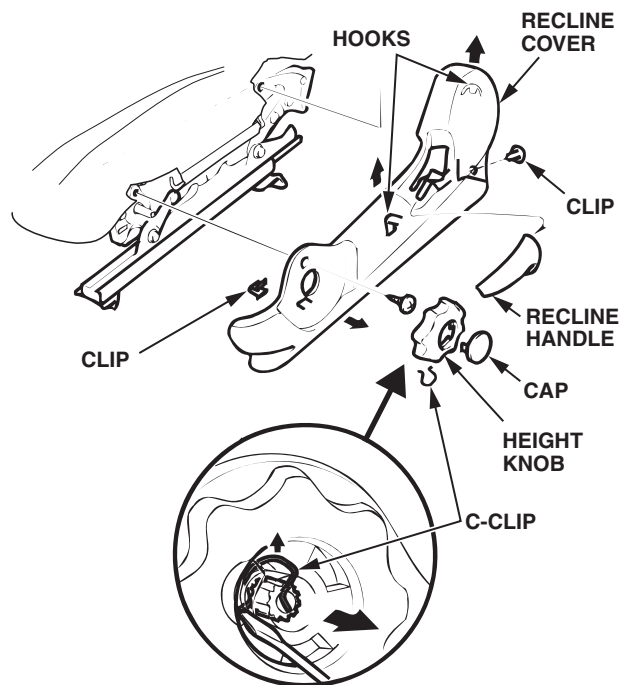
1. Remove the driver's seat from the vehicle. Refer to the body section in the 2001-02 Civic Shop Manual.
2. Remove the recline handle by pulling it forward.

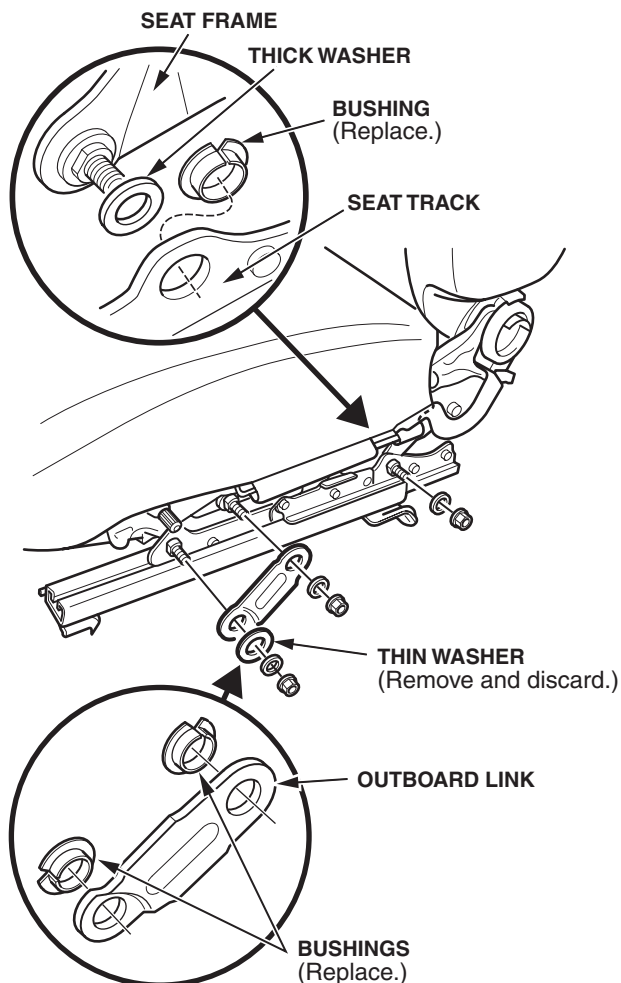
**Outboard Side:**

5. Remove the three nuts and washers from the outboard link and the outboard seat track.

6. Remove and discard the thin washer from the front link. Remove and discard the old bushings.
7. Install the new bushings.
8. Reassemble the outboard side of the seat track in the reverse order of removal. Torque the nuts to 24 N·m (17 lb-ft).  
NOTE: Make sure you install the thick washer in the same position.
9. Install the recline cover.

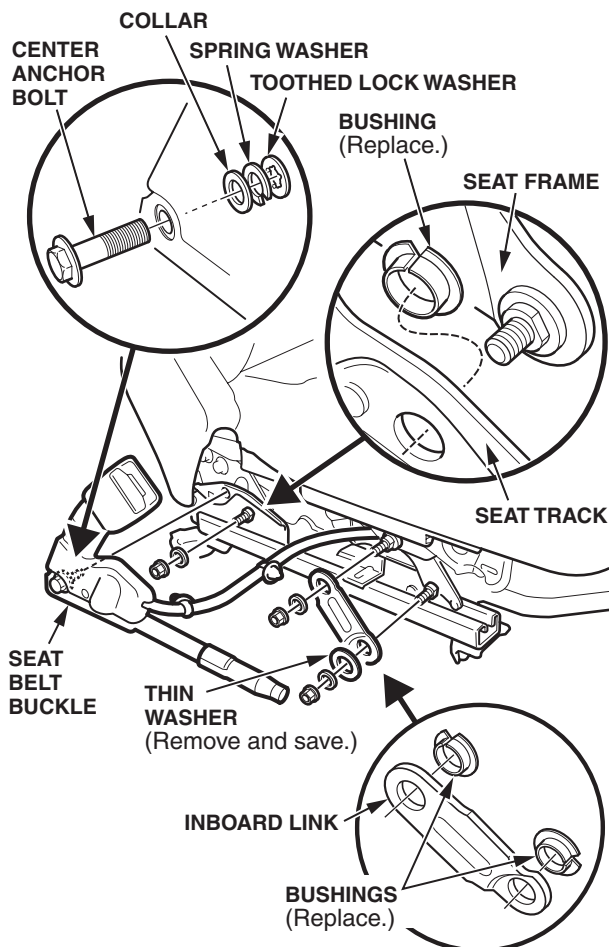
**Inboard Side:**

11. Remove the three nuts and washers from the inboard link and the inboard seat track. Remove and discard the old bushings.
12. Install the new bushings.

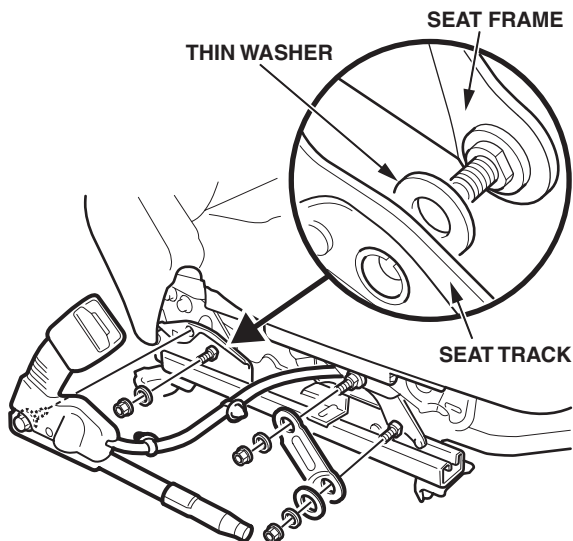
13. Install the thin washer that you removed from the front link on the rear mounting stud for the seat track.

14. Reassemble the inboard side of the seat track in the reverse order of removal. Torque the seat track mounting nuts to 24 N·m (17 lb-ft). Torque the seat belt buckle mounting bolt to 32 N·m (23 lb-ft).
15. Install the seat.
16. Confirm that the problem is resolved. If the driver's seat still rocks, look for other causes.
