Applies To: **See VEHICLES AFFECTED****July 20, 2007****Buzzing From the Engine at Low RPM**

(Supersedes 06-059, dated November 10, 2006, to update the information by the black bar)

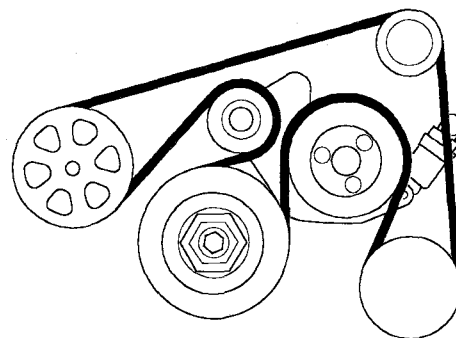
1. Remove the original drive belt:
 - Refer to page 4-40 of the *2006–2007 Civic Service Manual*, or
 - Online, enter keywords **DRIVE BELT**, and select **Drive Belt Removal/Installation (R18A1 and R18A4 Engine)** from the list.
2. Install the new drive belt, and route it as shown.

Install a longer, re-routed drive belt.
