Applies To: **2001-02 – ALL**
2003 Civic 2-Door – From VIN 1HGEM2...3L000001 thru 1HGEM2...3L071731
2003 Civic 4-Door – From VIN 1HGES....3L000001 thru 1HGES....3L032321

September 23, 2003

Water Leaks Into the Trunk From a Body Seam

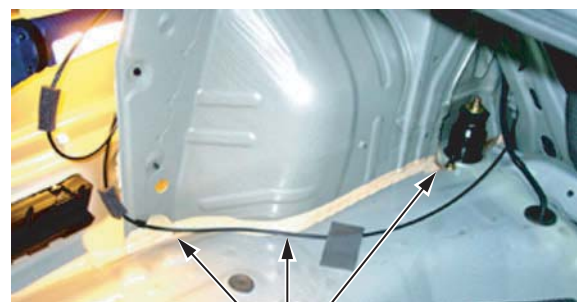
Driver's side shown

1. Clean and dry the affected area at the seam between the trunk floor and the wheelhouse. Apply 3M seam sealer to the affected areas shown.

NOTE: The leak may occur on the left and/or right side of the vehicle.

Apply sealer.

2. Allow 15 to 20 minutes for the seam sealer to cure.
3. Retest with water to verify that the leak has been repaired.
4. Reinstall the rear wheels, the spare tire cover, and the trunk liner.

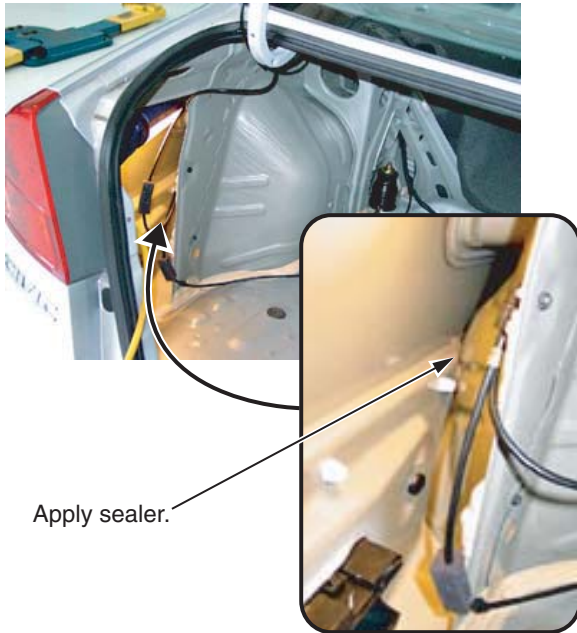
Driver's side shown

1. Clean and dry the affected area at the wheelhouse and side panel area. Apply 3M seam sealer to the area shown.

NOTE: The leak may occur on the left and/or right side of the vehicle.

2. Allow 15 to 20 minutes for the seam sealer to cure.
3. Retest with water to verify that the leak has been repaired.
4. Reinstall the rear wheels, the spare tire cover, and the trunk liner.

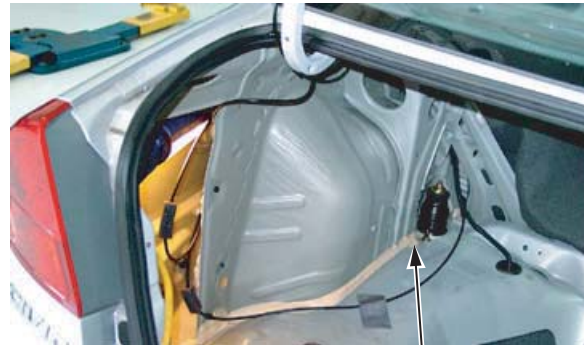
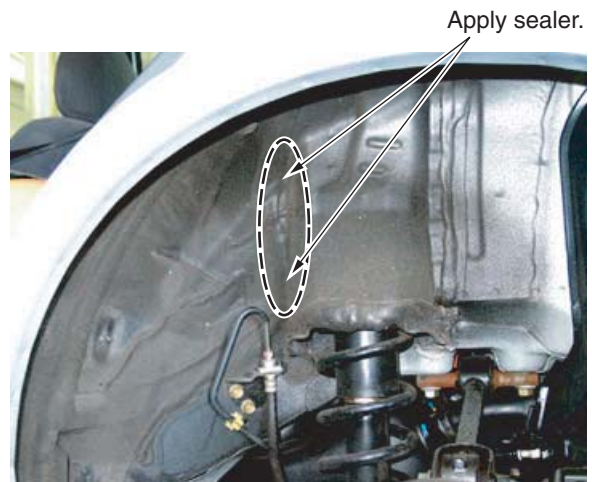
Driver's side shown

1. Clean and dry the affected area around the shock tower and around the seam in the wheelwell area. Apply 3M seam sealer to the areas shown.

NOTE: The leak may occur on the left and/or right side of the vehicle.

2. Allow 15 to 20 minutes for the seam sealer to cure.
3. Retest with water to verify that the leak has been repaired.
4. Reinstall the rear wheels, the spare tire cover, and the trunk liner.
